Organic Finishing Technologies

B-52 Paint Life Cycle Extension

Steve Finley, CTC
Support Contractor to
Mr. Tom Naguy
Air Force Research Laboratory

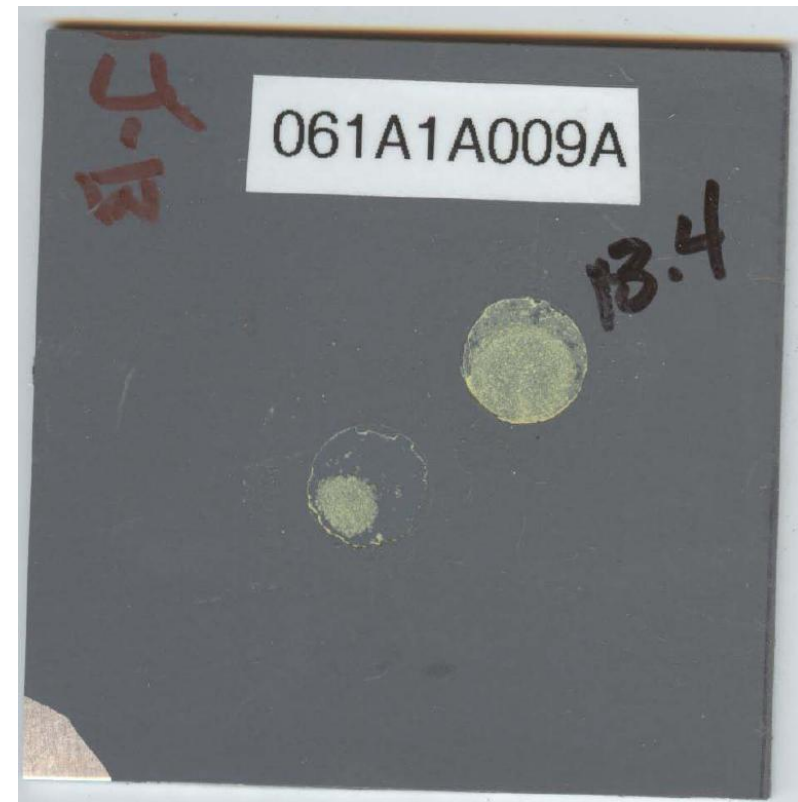
- Adhesion Testing using Pneumatic Adhesion Tensile Testing Instrument (PATTI) results
 - Six panels with two pulls per panel
 - Predominant failure mode was cohesive failure at the primer
 - Three panels showed adequate pull strength
 - Three panels were lower than desired

Panel ID	1 st Pull PSI	2 nd Pull PSI	AVERAGE PSI
61A1A007A	1048	1105	1076.5
61A1A007B	1011	1452	1231.5
61A1A008A	1293	1105	1199
61A1A008B	484	713	598.5
61A1A009A	631	541	586
61A1A009B	395	599	497

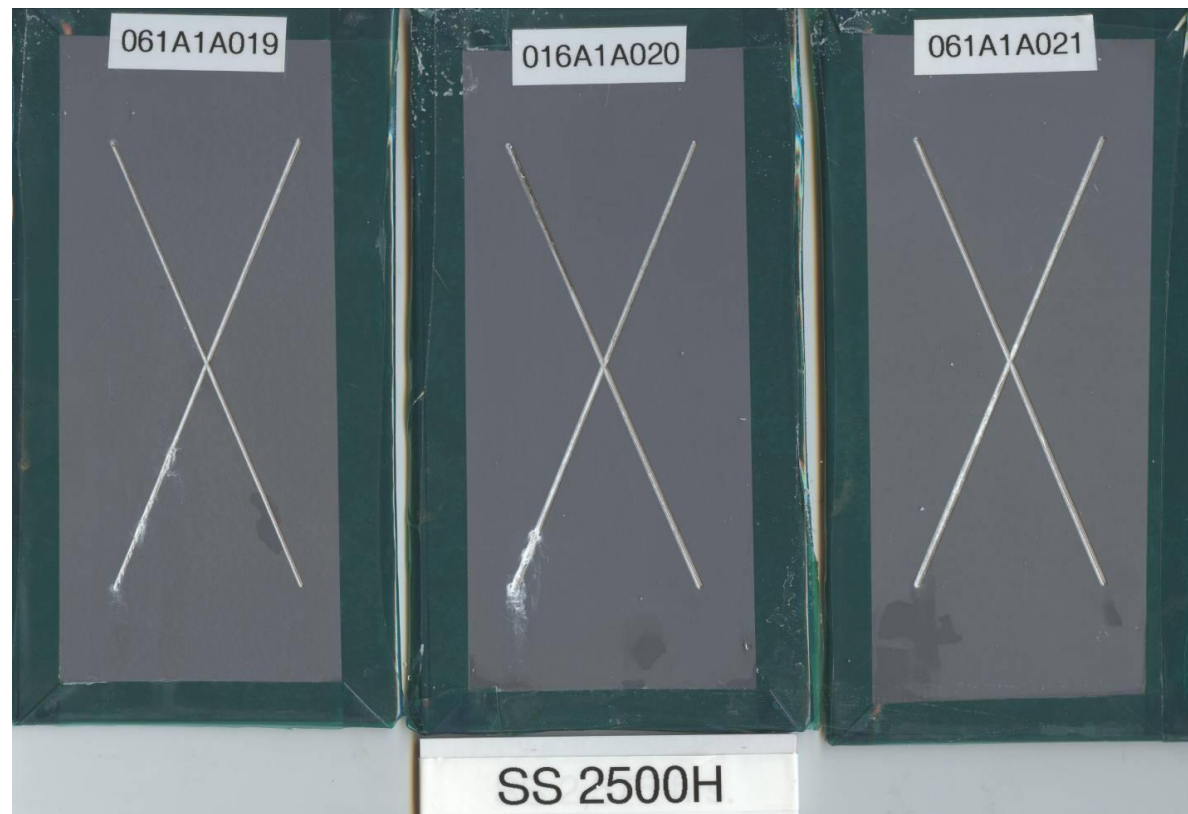
- Neutral Salt Fog Corrosion Resistance Testing

- Tested in accordance with ASTM B-117 *Standard Practice for Operating Salt Fog Apparatus*
- Slight corrosion in the scribe at 500 hours; no change for the remainder of testing

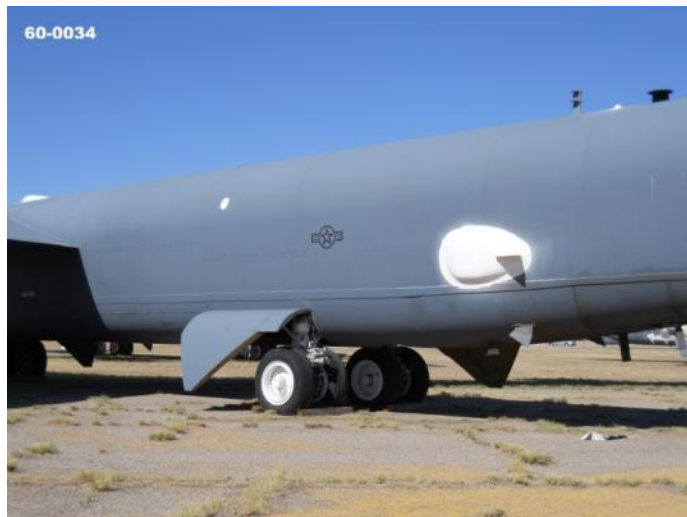
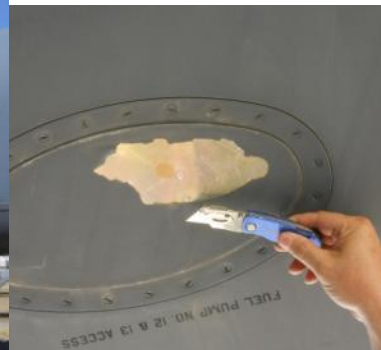
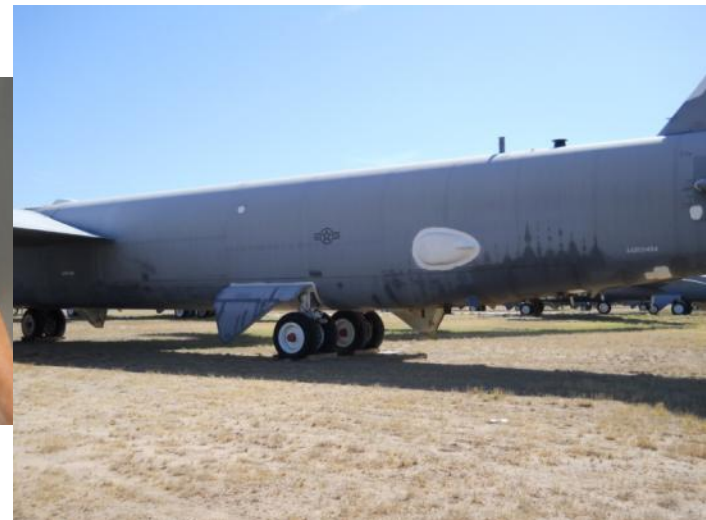
- One adhesion failure noted on the inboard fuel access panel on the bottom of the right wing aircraft 60-0014
- Aircraft from Barksdale showed higher degree of coating degradation
- Minot aircraft showed little signs of degradation
- No corrosion noted on any of the aircraft observed

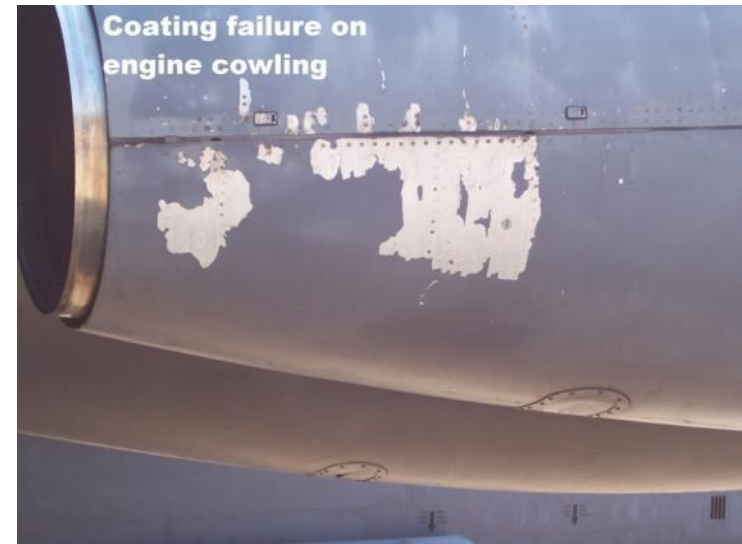
- **Barksdale Inspection Results**
 - Several adhesion failures noted on multiple aircraft
 - No corrosion was detected during the visual inspection
 - No facility to accomplish maintenance touch up
 - Color, gloss, and film thickness readings taken on the two aircraft with advanced performance coating (APC)

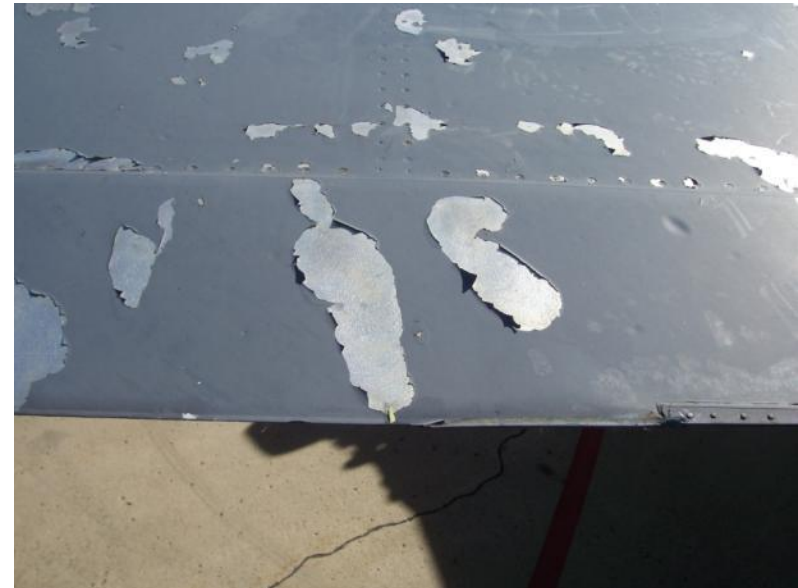
- **Minot Inspection Results**
 - Several adhesion failures noted on multiple aircraft; some as large as 20 ft²
 - No corrosion was detected during the visual inspection
 - No facility to accomplish maintenance touch up
 - Color, gloss, and film thickness readings taken on three APC aircraft

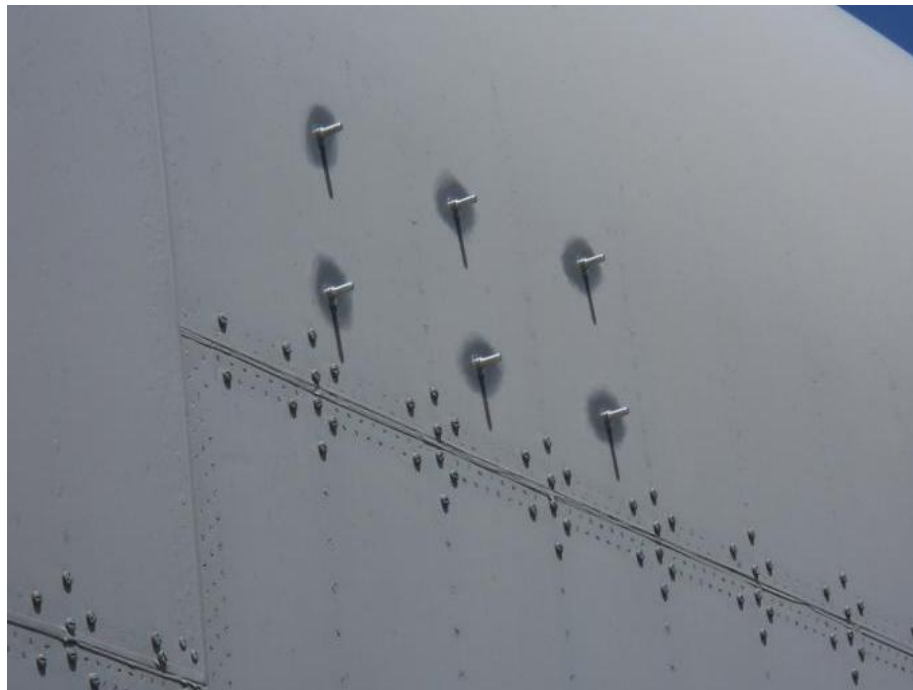
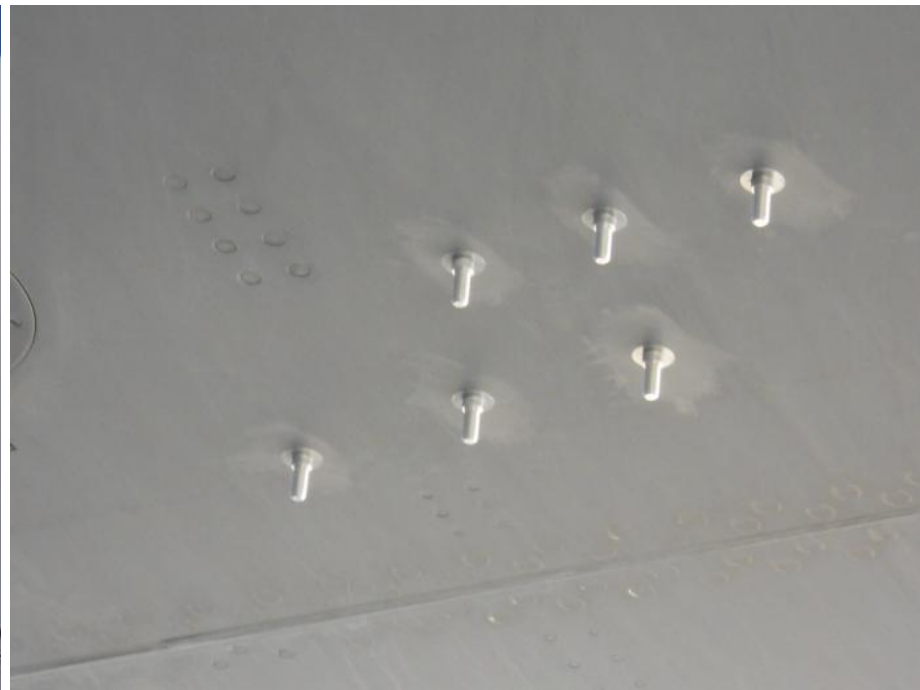
- Twelve studs glued to each aircraft
- Six under the right wing
- Six on the aft fuselage right side

Serial Number	Base Assigned	Under Wing Pull PSI	Predominant Failure Mode	Fuselage Pull PSI	Predominant Failure Mode
61-0007	AMARG (MT)	1020.4	Adhesive glue	No Reading	
60-0034	AMARG (MT)	1776.2	Adhesive glue	901.4	Adhesive glue
60-0014	AMARG (LA)	728.5	Adhesive glue	No Reading	
61-0024	AMARG (LA)	1183.1	Adhesive glue	No Reading	
60-0019	AMARG (LA)	1117.0	Adhesive glue	459.9	Adhesive glue
60-0016	Barksdale	2,030.6	Cohesive primer	1,394.5	Cohesive primer
61-0020	Barksdale	2,059.8	Cohesive primer	1,358.4	Cohesive primer
61-0012	Barksdale	1,828.0	Cohesive primer	1,456.5	Cohesive primer
60-0001	Barksdale	2,374.2	Cohesive primer	1,605.4	Cohesive primer
61-0032	Minot	1476.2	Adhesive glue	521.8	Adhesive glue
61-0029	Minot	1880.3	Adhesive glue	776.9	Adhesive glue
61-0034	Minot	1440.3	Adhesive glue	729.9	Adhesive glue

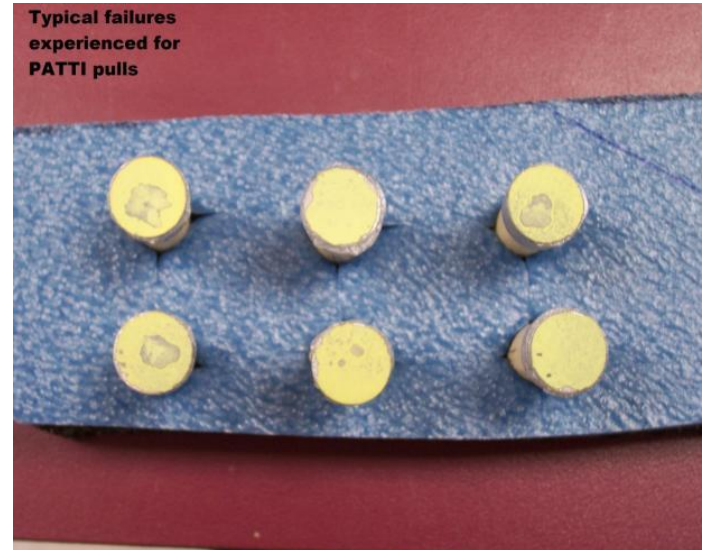
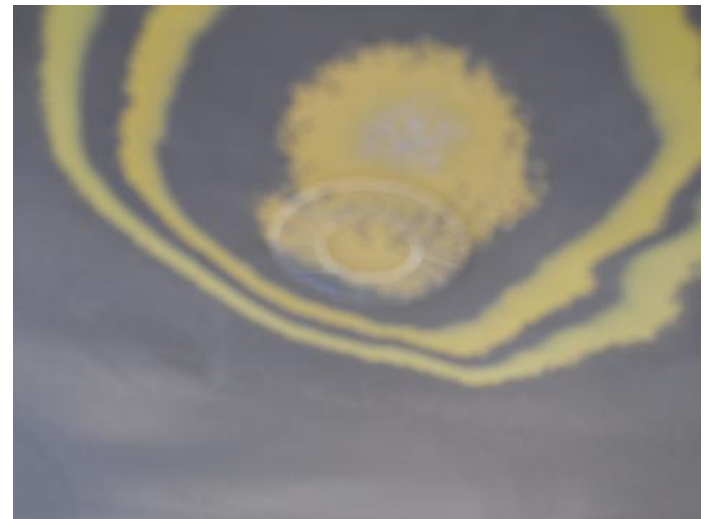
- **X-Ray Photoelectron Spectroscopy (XPS)**
 - Primer samples collected for XPS analysis
 - Coating was sanded to the base primer layer
 - Dust was collected on tape
 - PATTI studs were used for analysis
 - Fourteen samples were analyzed
- **Cr +6 level equal to or greater than fresh applied primer in 13 of 14 samples**
